I MICRO GUARD HEAT DISPLACEMENT GUARD

MICRO GAUZE HEAT DISPLACEMENT GUARD

**Sites share an innovative
idea 8,100km apart to solve
a similar problem**

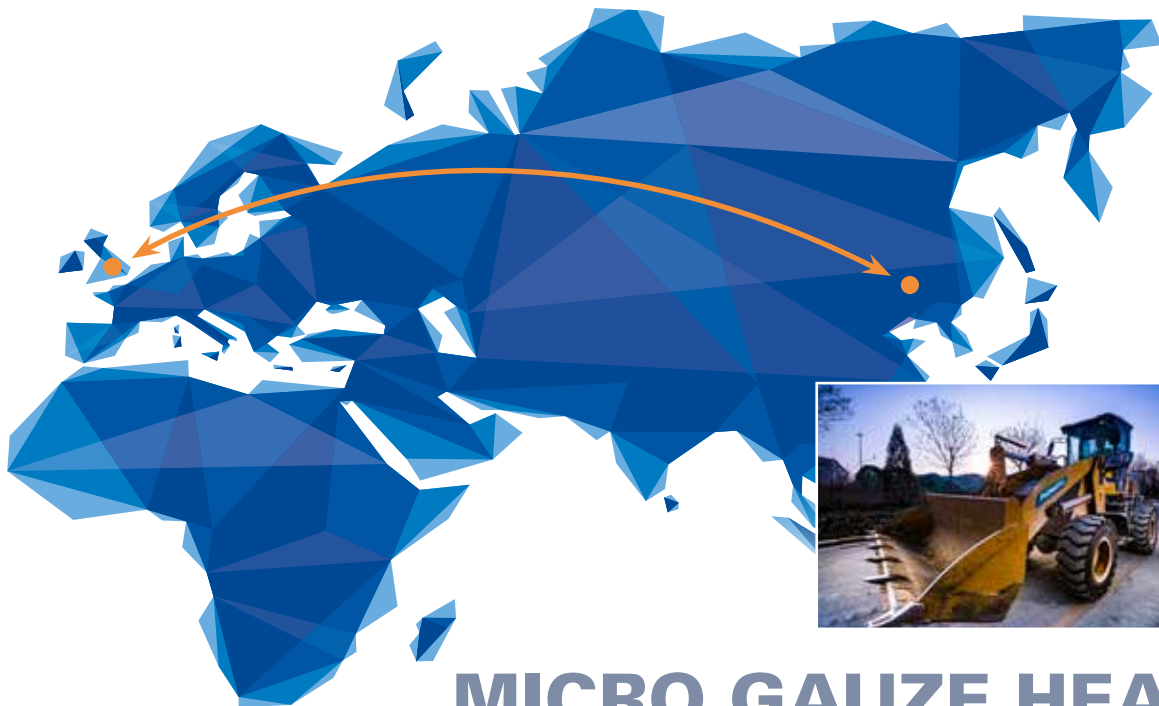
**“As the excavator is close to the
pit wall the cabin is exposed to
temperatures > 500°C. ”**

On one customer site in Europe, the hot slag is extracted from a deep pit through the use of a hot work excavator driven by a Harsco employee. As the excavator is close to the pit wall the cabin is exposed to temperatures > 500°C during the operation. The extreme heat is unpleasant for the operator and causes the excavator cabin screen to crack, regularly causing asset downtime and potential delays to the service.

The maintenance leader researched heat resistant glass and materials that could be retrofitted to the screens of the excavator cab. After a series of unsuccessful trials, a micro-gauze material was installed the full length of the cabin front screen.

A simple steel frame was fabricated and installed in front of the screen guard, with the micro-gauze secured into the frame with bolts.

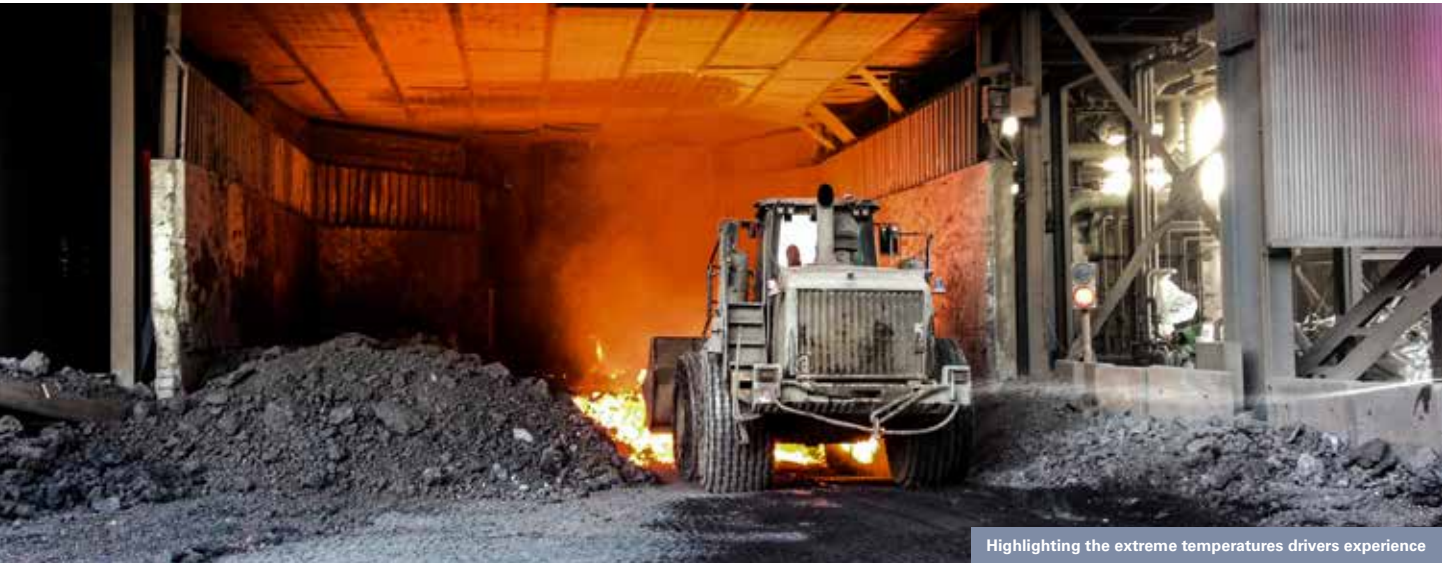
Highlighting the extreme temperatures drivers experience
